REPORT OF MULTIPLE FATAL BUMP ACCIDENT  
SUNNYSIDE NO. 1 MINE  
KAISER STEEL CORPORATION  
SUNNYSIDE, CARBON COUNTY, UTAH

December 4, 1957

Thomas T. Reay, Jr.  
Coal-Mine Inspector

Lester L. Naus  
Mining Health and Safety Engineer

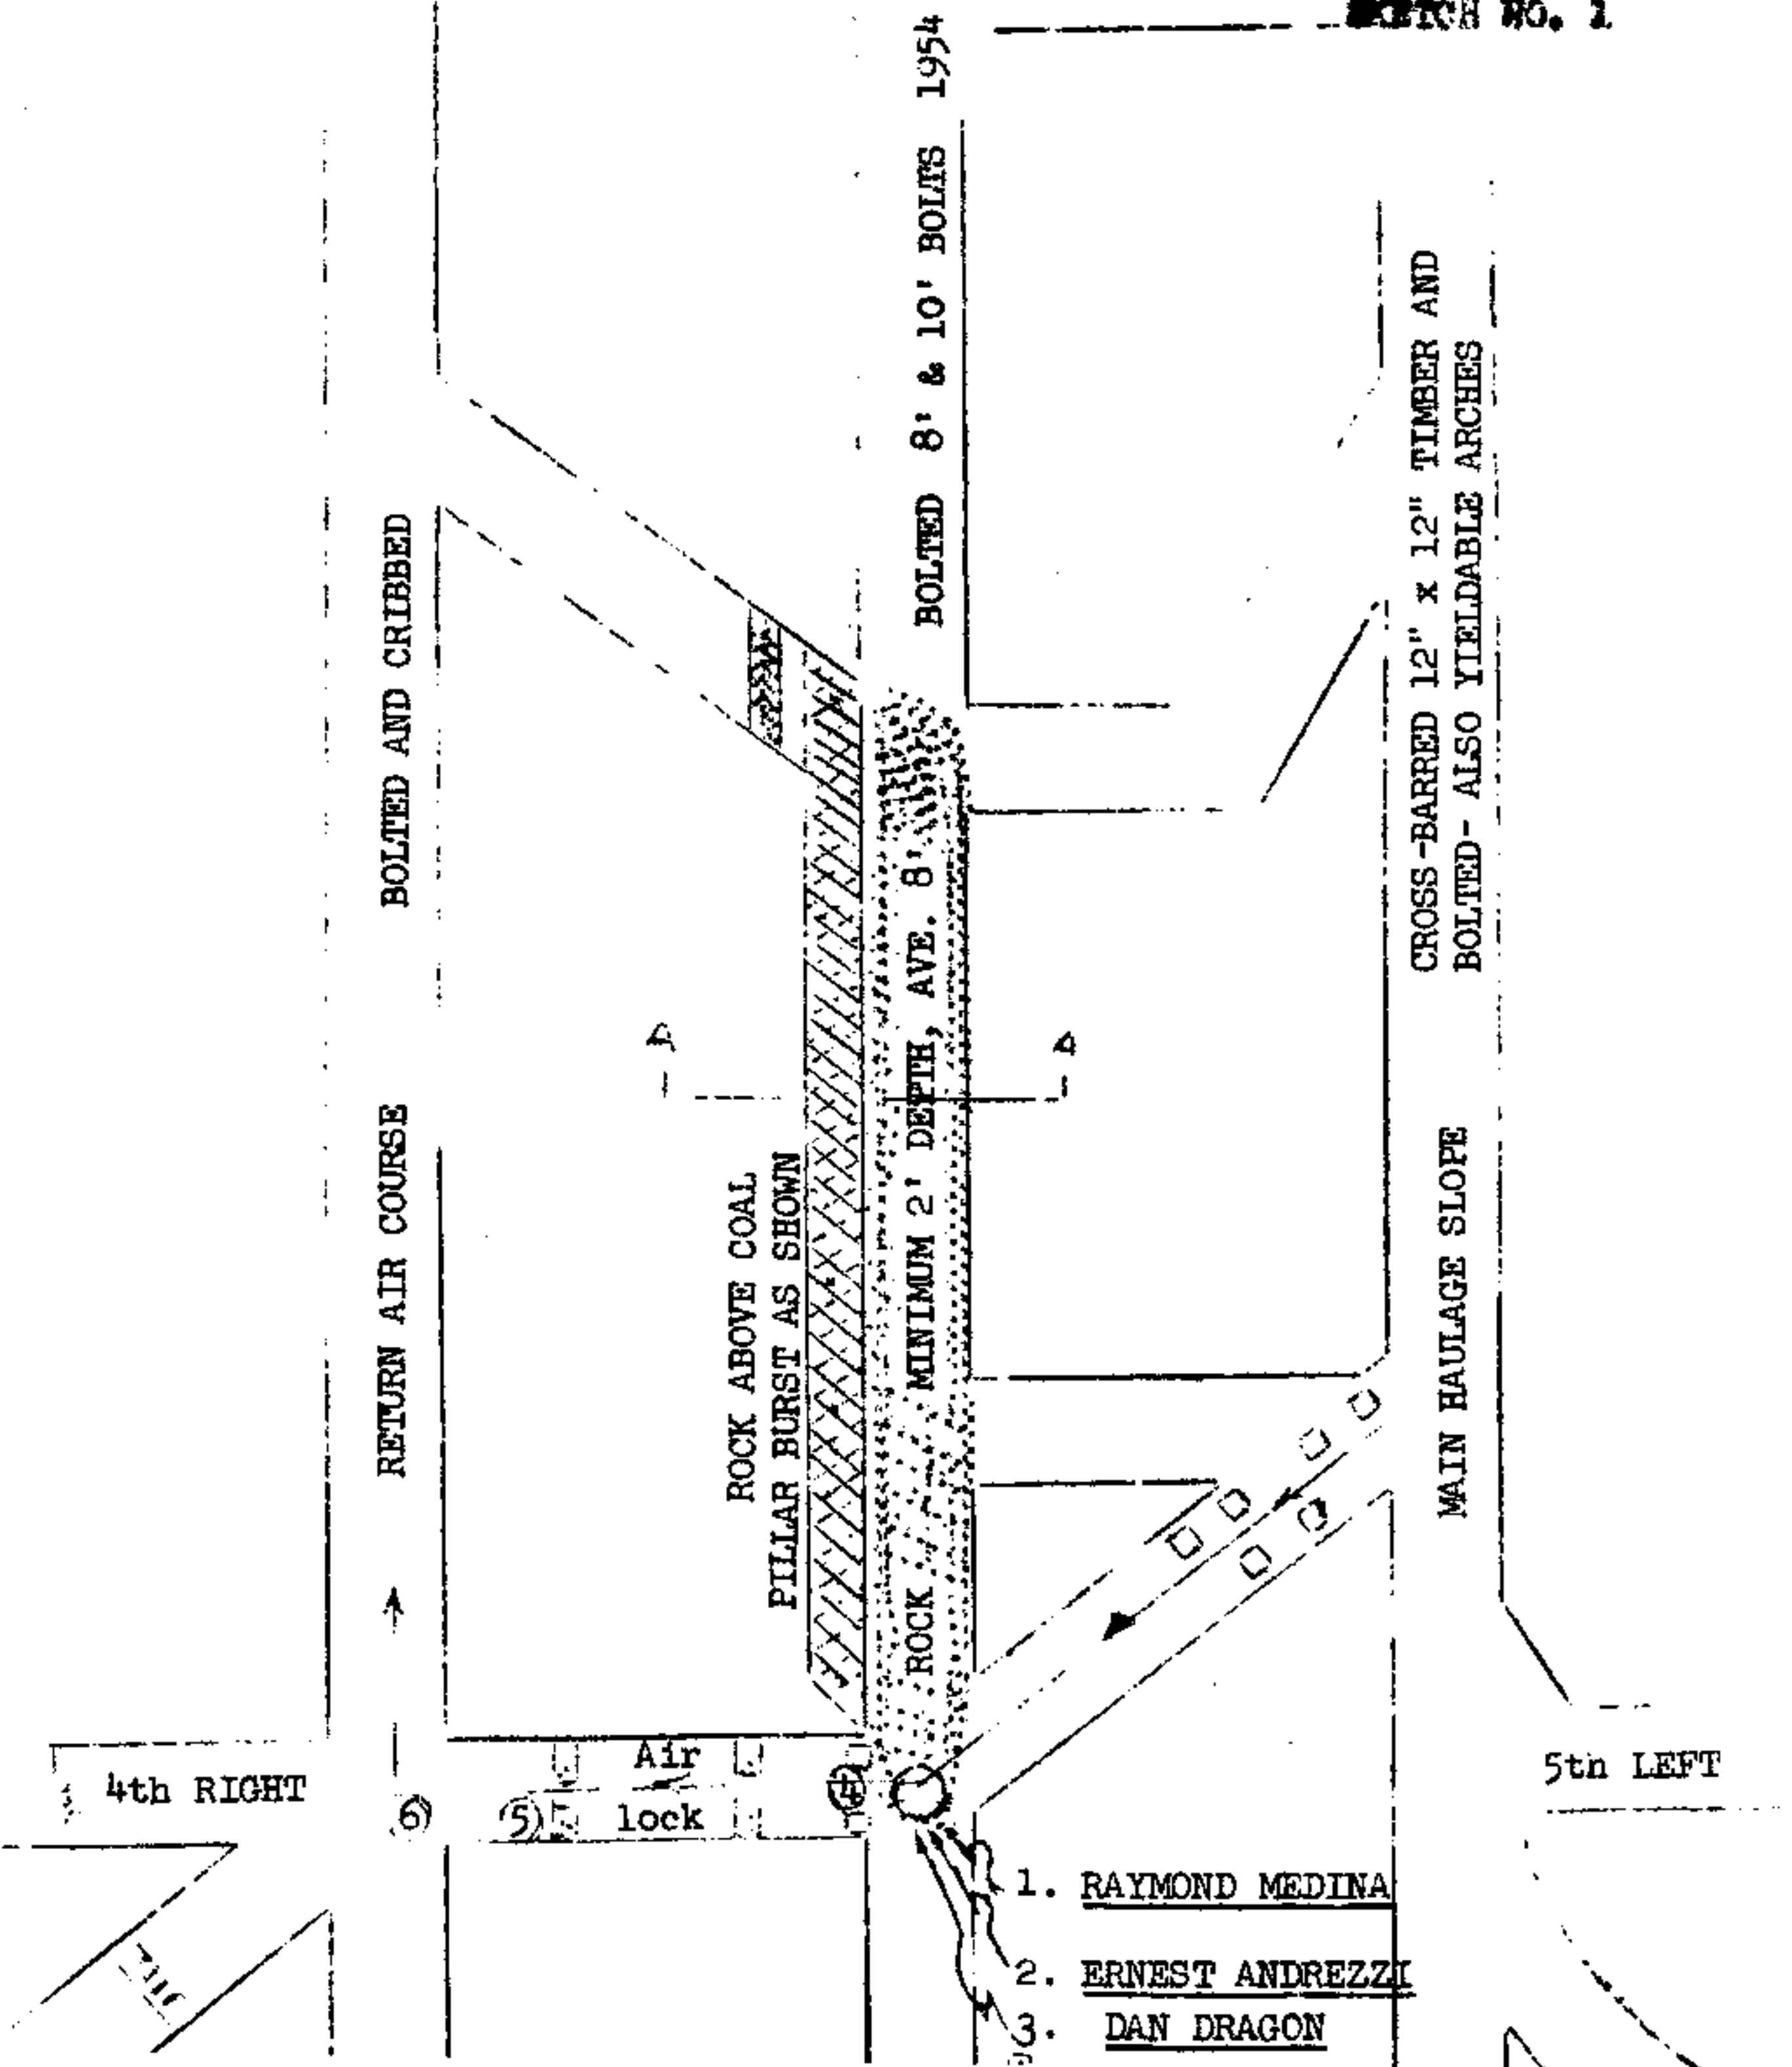
The appended map shows areas of the Sunnyside No. 1 mine that have been seriously affected by bumps during 1957. Essentially the same areas affected by bumps of January 24 and 27, 1957 were involved in bumps in 1944 and 1952, respectively. The bump of 1944 caused caving of the roof along the No. 2 slope and the bump of 1952 was manifest to the portals of raise entries driven to the surface from the present motor road. It is understood that intermittent bumps had occurred in the goaf area on the

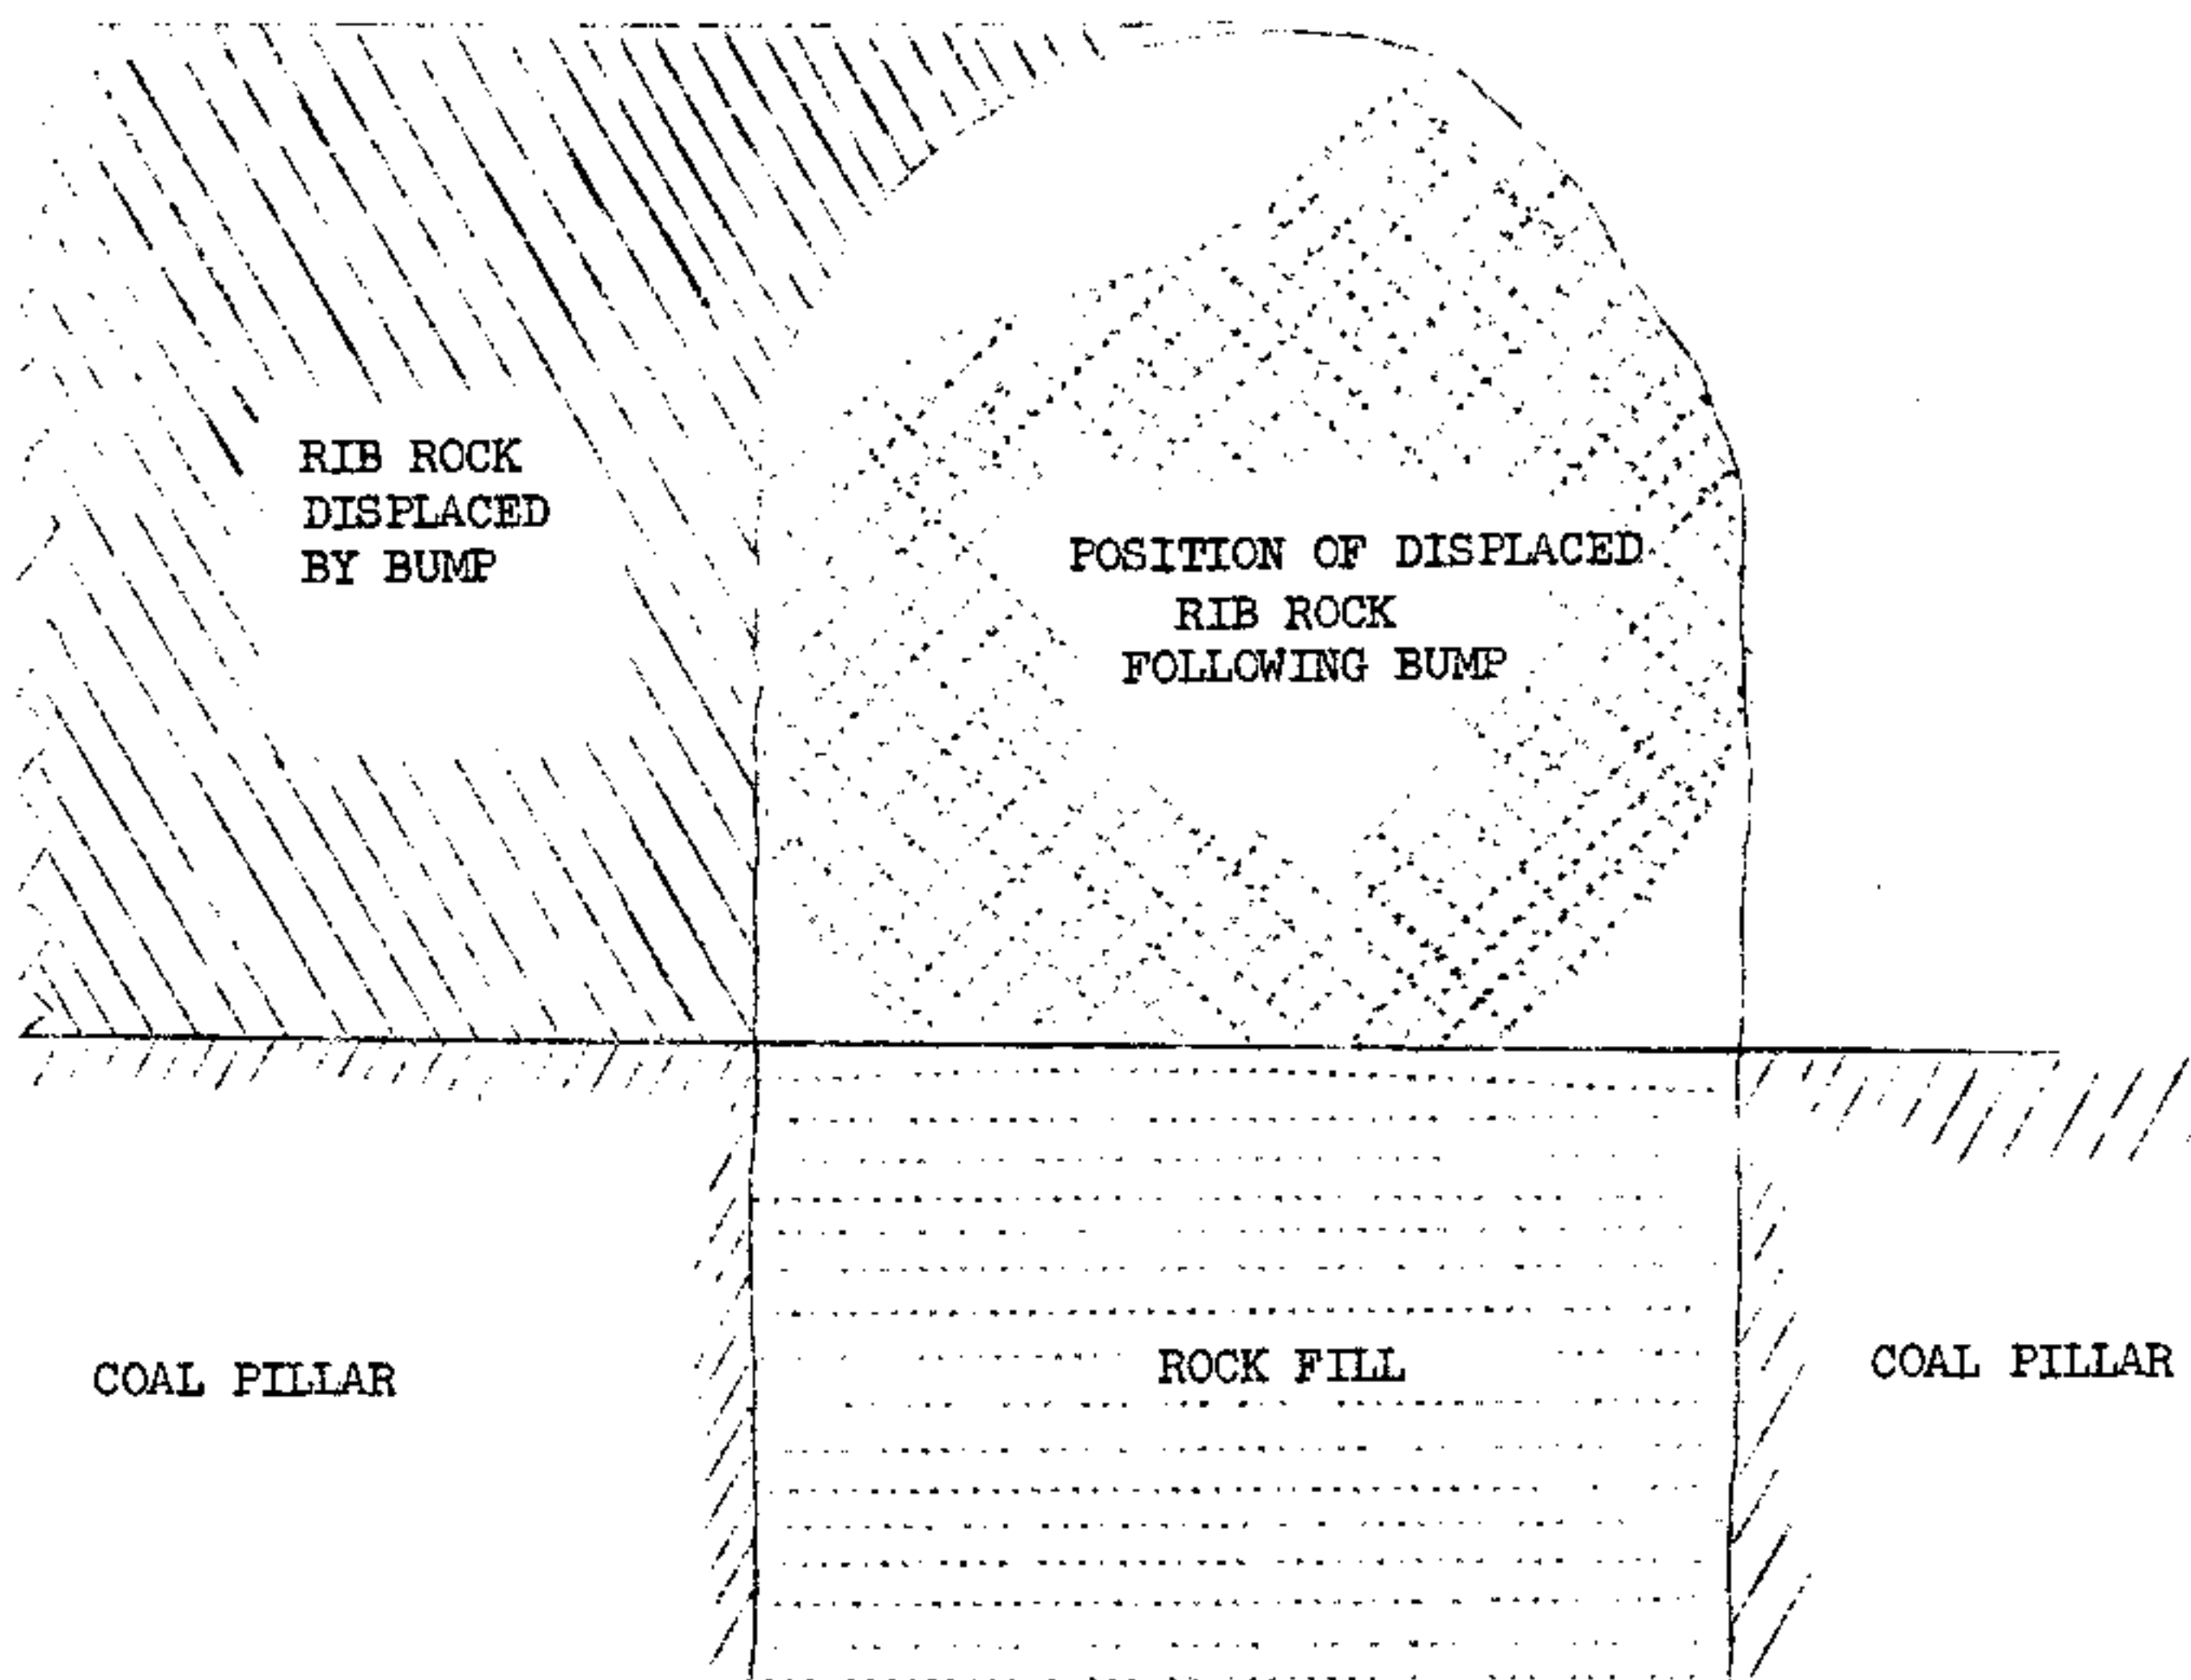
SKETCH NO. 2

As far as could be determined when the affected area was visited on December 5 and 6, the force of the bump appeared to have been expended in the rock overlying the coal along the right (south) rib of the manway. The rib rock appeared to have been thrown out enmasse into the manway which was filled to within  $3\frac{1}{2}$  feet of the roof. The rock broke near the center line of the roof in the oval shaped manway with the roof to the left (north) side showing no effects other than the splintering of the wooden head blocks bolted in place. Roof bolts in the displaced rib rock were badly bent and apparently were pulled from their anchorage marked in some instances by the wedges still in place in the roof.

SECTION THROUGH A - A OF SKETCH  
OF MULTIPLE BUMP FATALITY  
SUNNYSIDE NO. 1 MINE  
WEDNESDAY, DECEMBER 4, 1957
